Formal Complaint and Escalation Request

Repeated Cybertruck Charging Failures and Service Center Refusal to Repair After an Ordered Replacement Part Arrived

Vehicle: Tesla Cybertruck / Foundation Series

Service Center: Tesla Service Temecula / Tesla Temecula Rancho Way, 43191 Rancho Way, Temecula, CA 92590

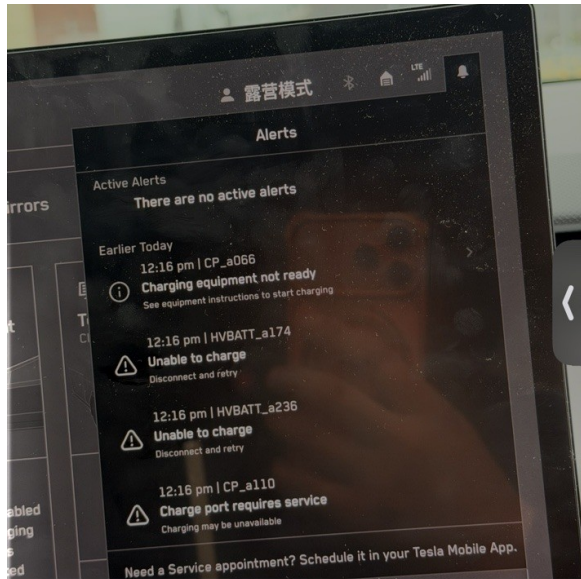
Event 1: vehicle screenshot / photo metadata

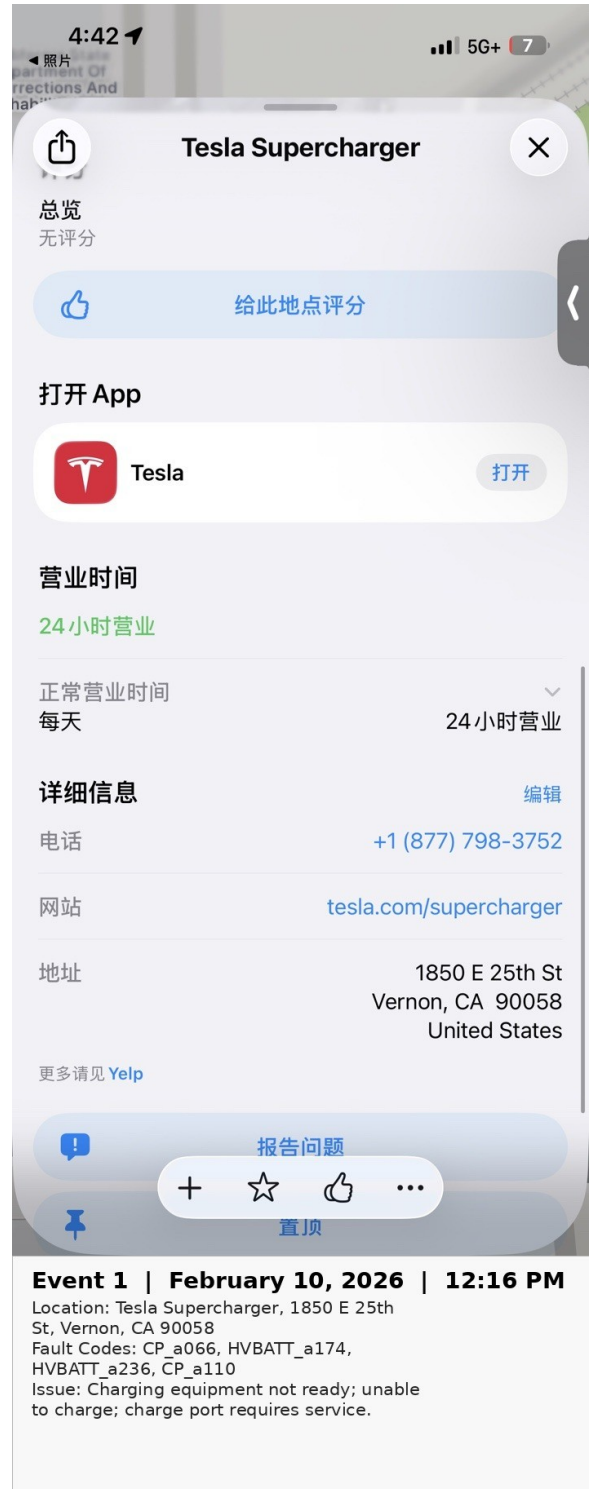
Event 1: charging-site location evidence

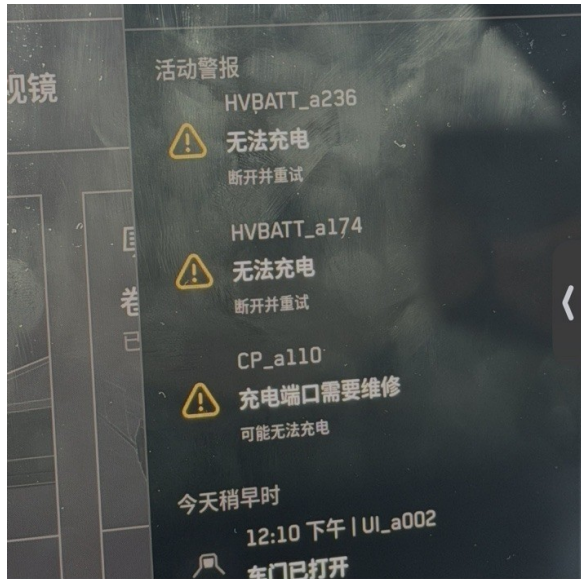
Event 2 | February 26, 2026 | 12:33 PM
Location: Tesla Supercharger, 1850 E 25th St, Vernon, CA 90058
Fault Codes: HVBATT_a236, HVBATT_a174, CP_a110
Issue: Unable to charge; repeated charge port service warning.

Event 2: vehicle screenshot / photo metadata

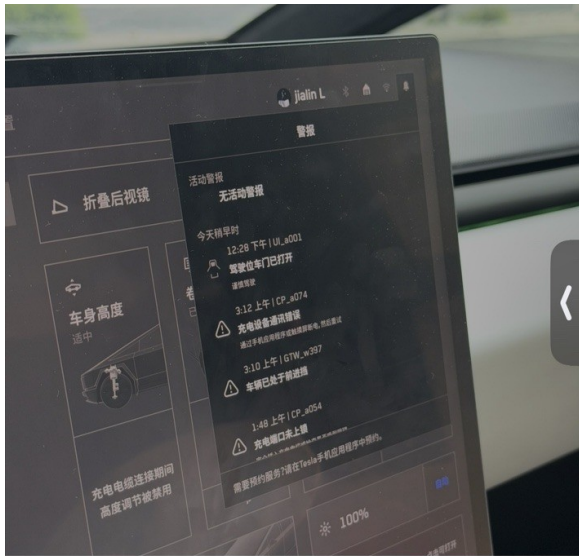
Event 3 | April 30, 2026 | 6:05 PM

Location: Rivian Adventure Network, 2200 Louisiana Blvd NE, Albuquerque, NM 87110
 Fault Codes: CP_a074, CP_a054
 Issue: Charging equipment communication error; charge port latch / lock warning.

Event 3: vehicle screenshot / photo metadata

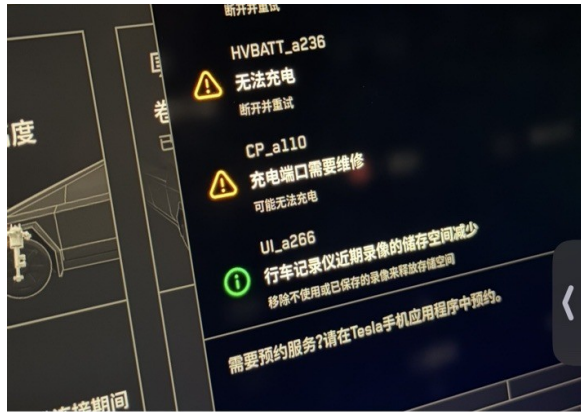
Event 4 | May 31, 2026 | 9:41 PM

Location: Tesla Supercharger, 18558 Gale Ave, City of Industry, CA 91748
 Fault Codes: HVBATT_a236, CP_a110
 Issue: Unable to charge; charge port requires service.

Event 4: vehicle screenshot / photo metadata

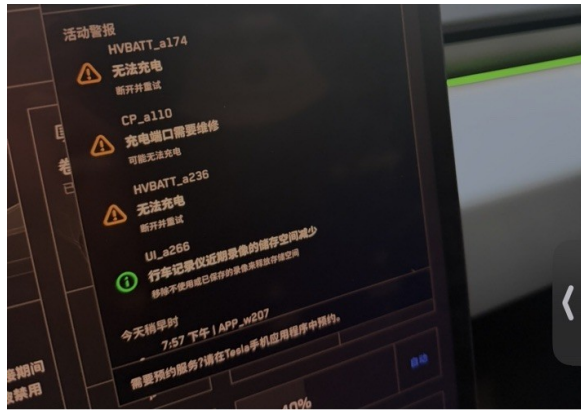
Event 5 | June 14, 2026 | 8:15 PM

Location: Tesla Supercharger, 2700 W 120th St, Hawthorne, CA 90250

Fault Codes: HVBATT_a174, CP_a110, HVBATT_a236

Issue: Repeated charging interruption; charge port requires service.

Event 5: vehicle screenshot / photo metadata

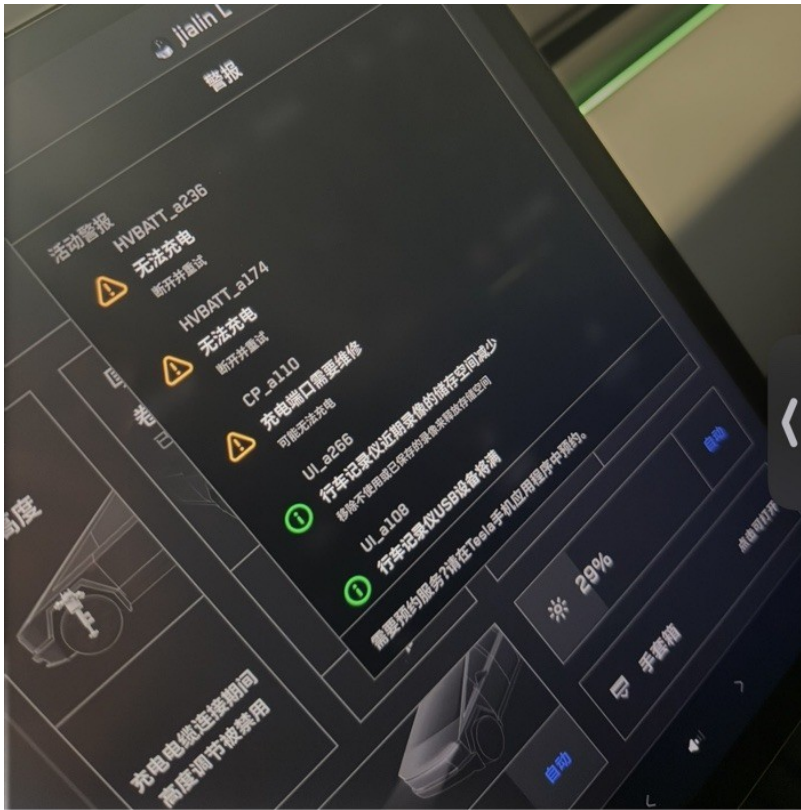
Event 6 | July 1, 2026 | 8:38 PM

Location: Irvine Spectrum / Spectrum Center area, Irvine, CA

Fault Codes: HVBATT_a236, HVBATT_a174.

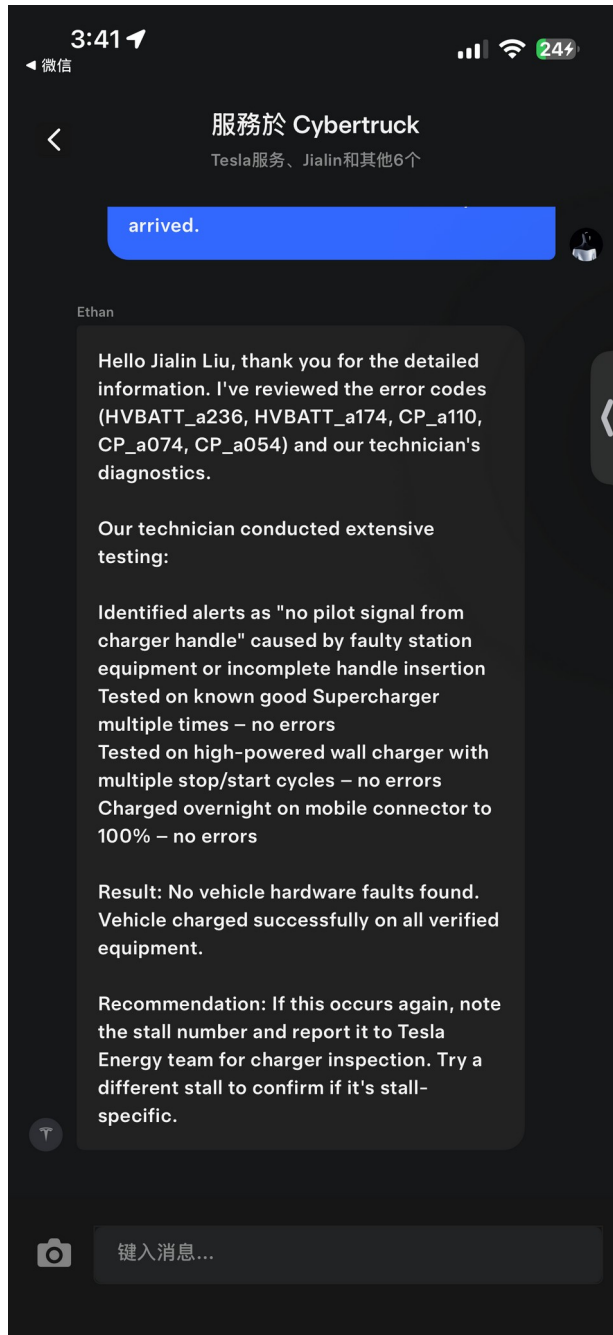
Service message stating that no vehicle hardware fault was found and recommending that I note the stall number next time.

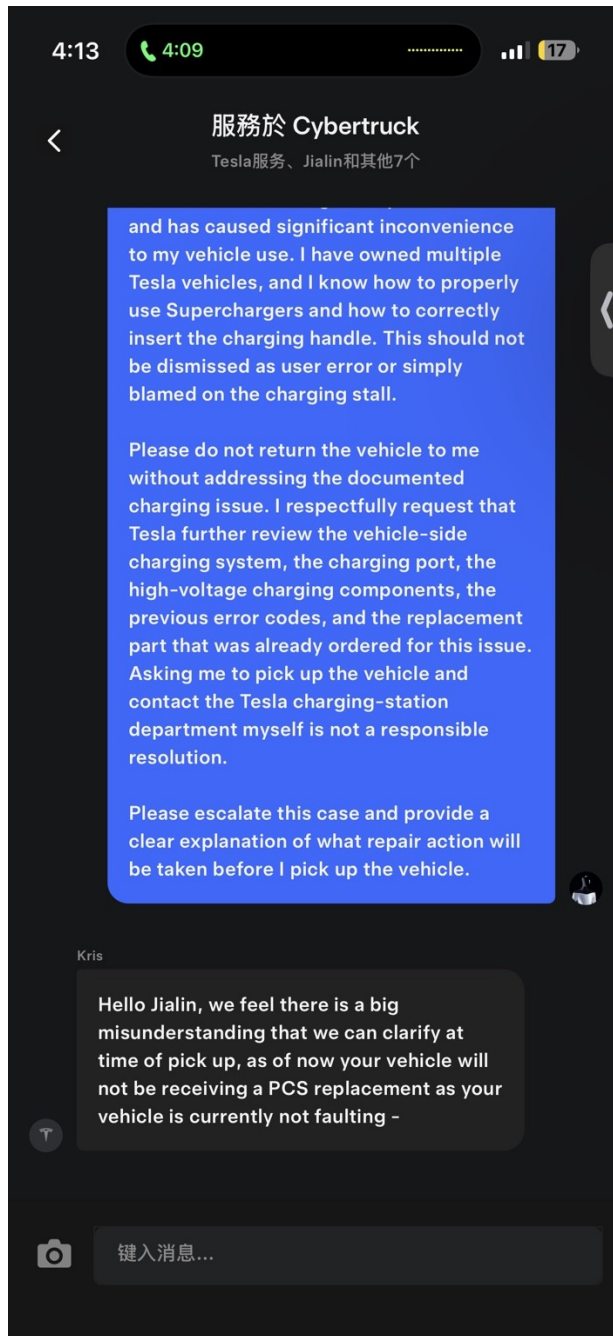
Service response stating that the vehicle would not receive a PCS replacement because it was not currently faulting.
