Formal Complaint and Escalation Request

Repeated Cybertruck Charging Failures and Service Center Refusal to Repair After an Ordered Replacement Part Arrived

Vehicle: Tesla Cybertruck / Foundation Series

Service Center: Tesla Service Temecula / Tesla Temecula Rancho Way, 43191 Rancho Way, Temecula, CA 92590

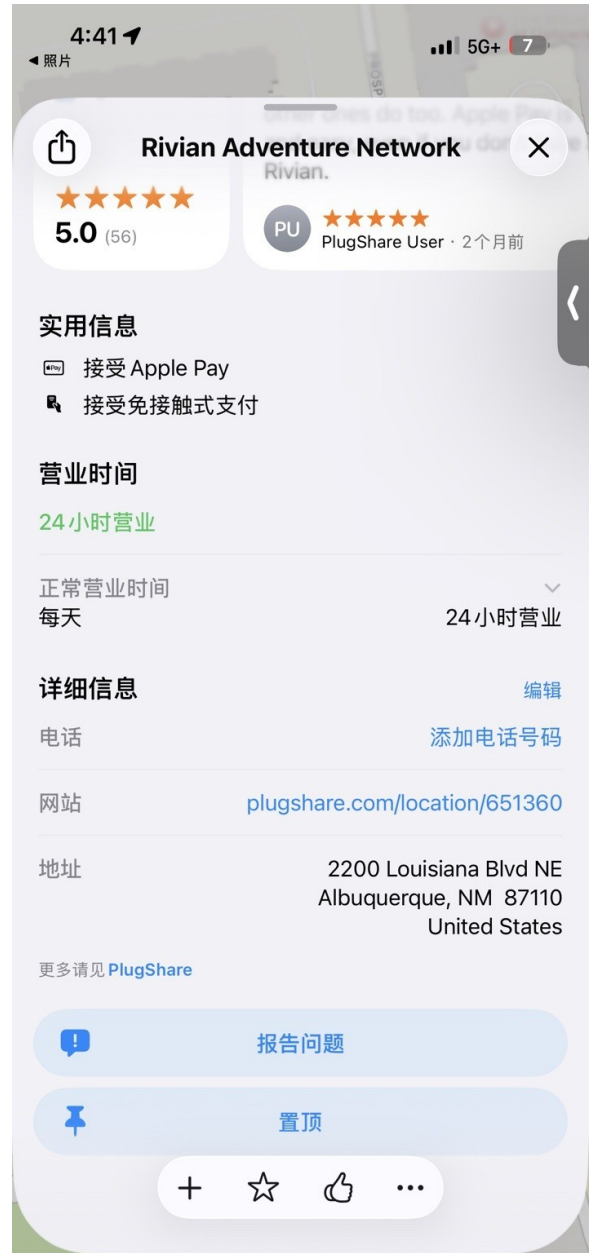
Event 3 | April 30, 2026 | 6:05 PM

Location: Rivian Adventure Network, 2200 Louisiana Blvd NE, Albuquerque, NM 87110
 Fault Codes: CP_a074, CP_a054
 Issue: Charging equipment communication error; charge port latch / lock warning.

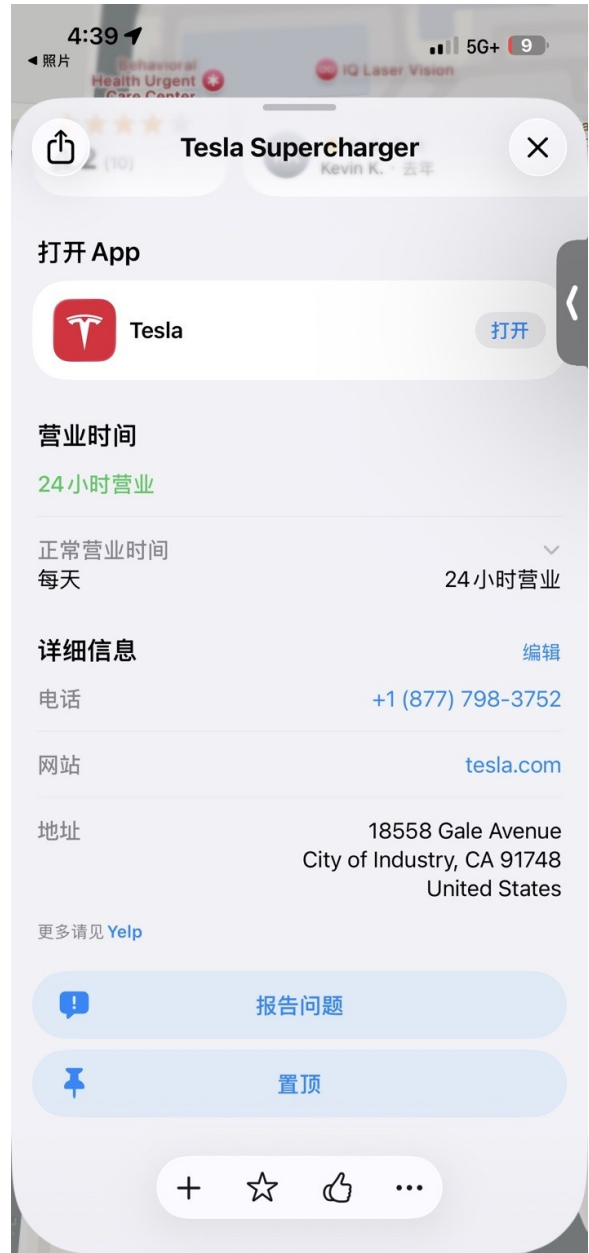
Event 4 | May 31, 2026 | 9:41 PM

Location: Tesla Supercharger, 18558 Gale Ave, City of Industry, CA 91748
 Fault Codes: HVBATT_a236, CP_a110
 Issue: Unable to charge; charge port requires service.

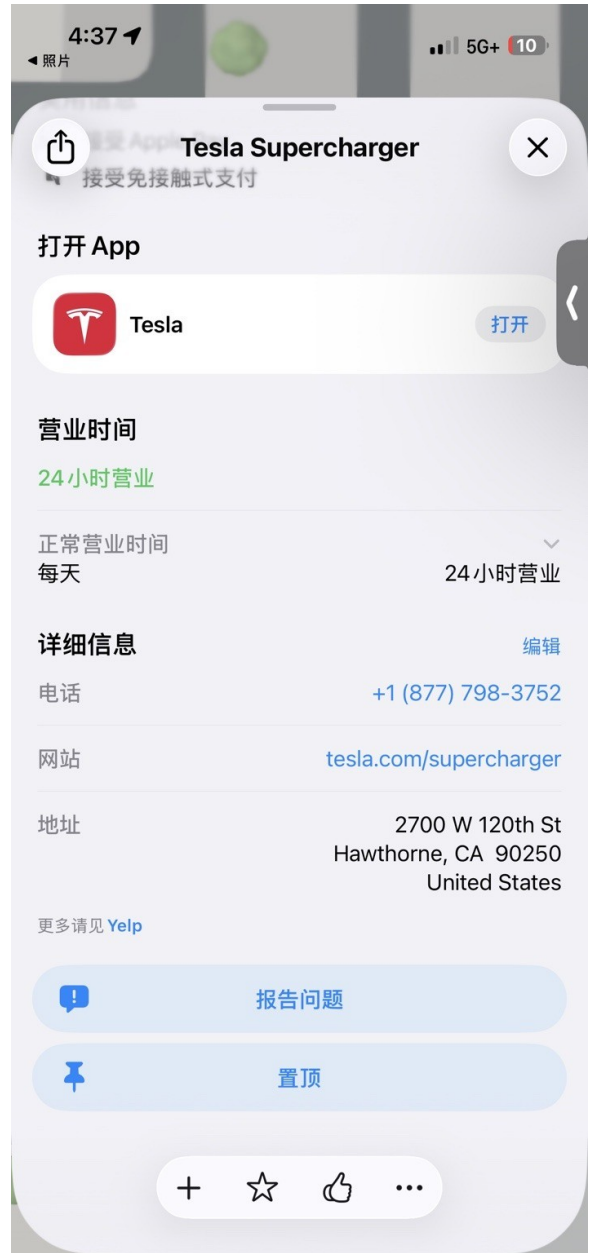
Event 5 | June 14, 2026 | 8:15 PM

Fault Codes: HVBATT_a174, CP_a110, HVBATT_a236

Issue: Repeated charging interruption; charge port requires service.

Location: Tesla Supercharger, 2700 W 120th St, Hawthorne, CA 90250

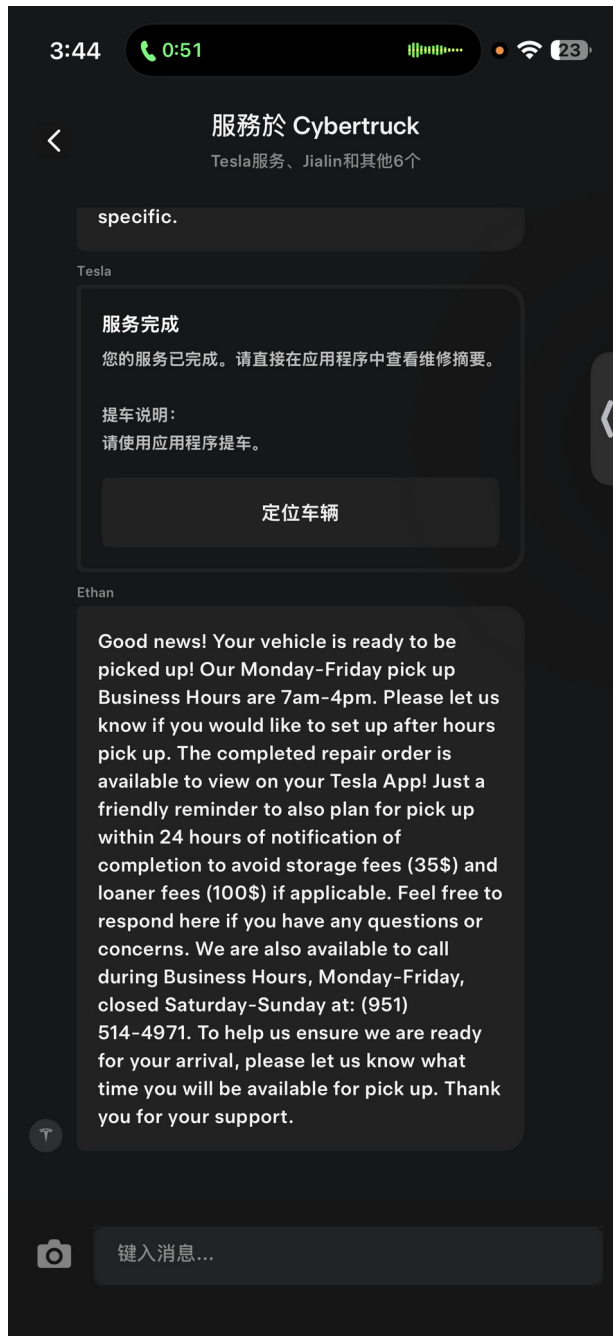
Service-complete / vehicle pick-up message.
